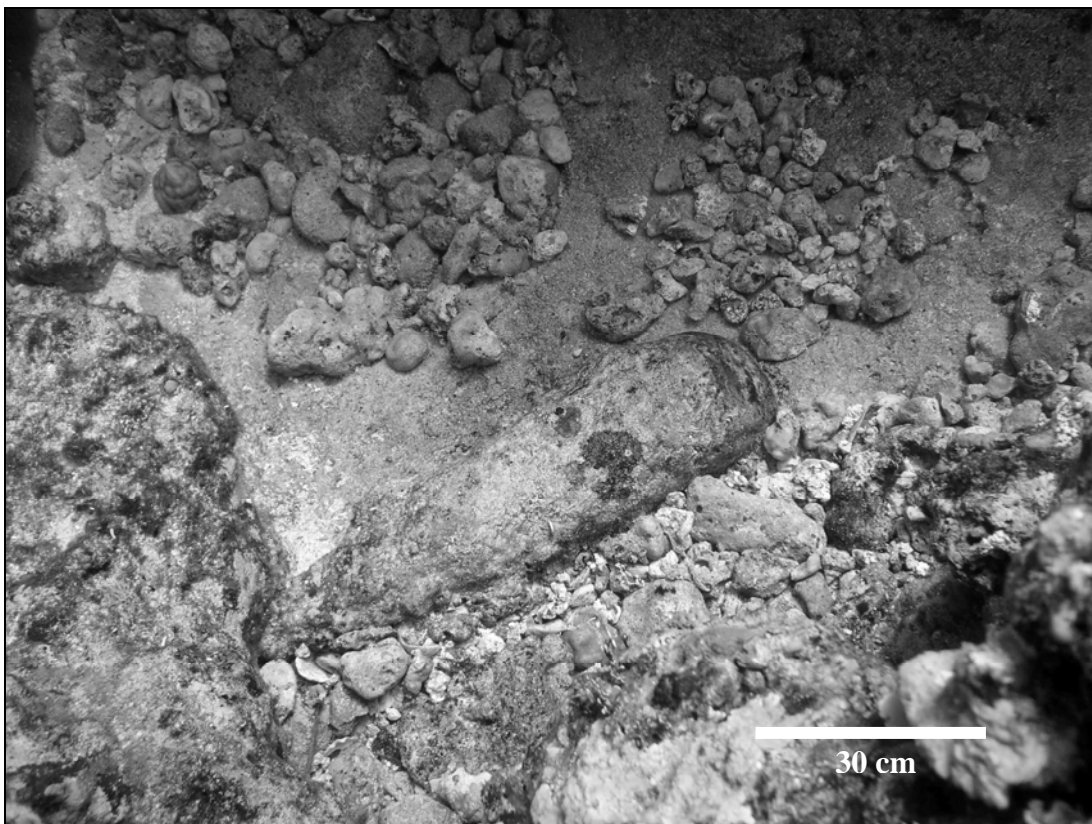
Photo 29. Ordnance at site UXO 36.

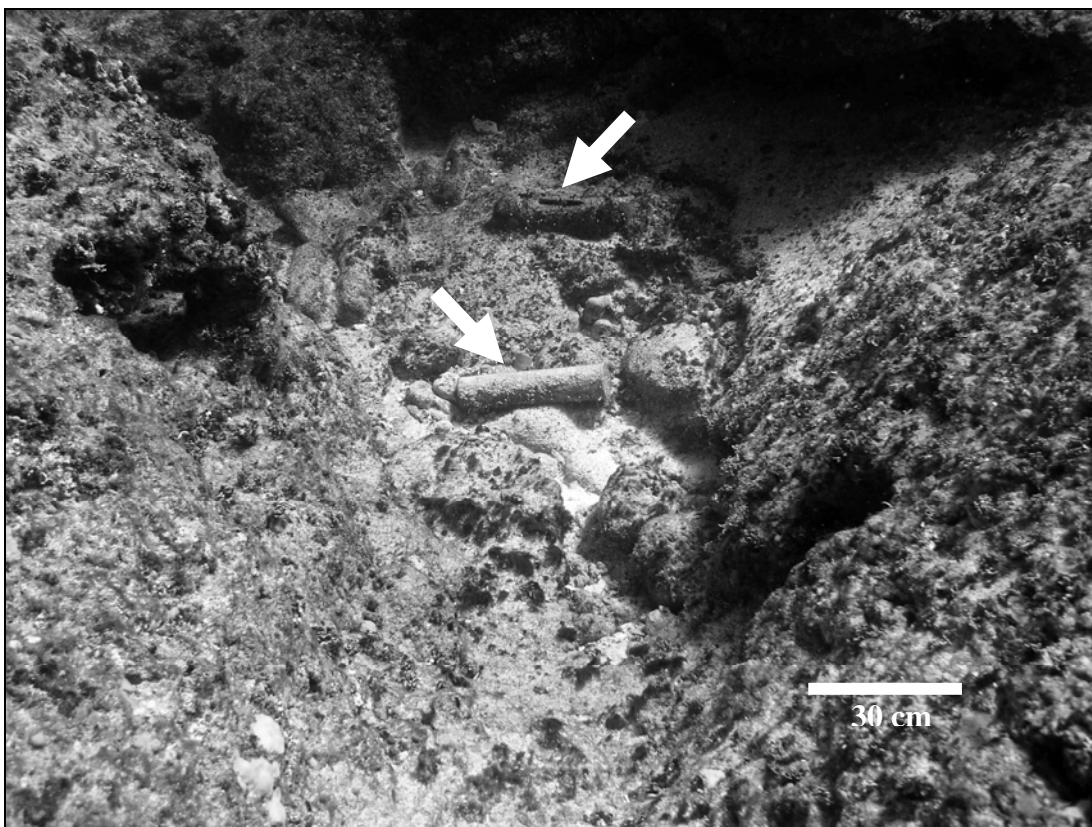
Photo 30. Multiple ordnance in a crevice at site UXO 37.

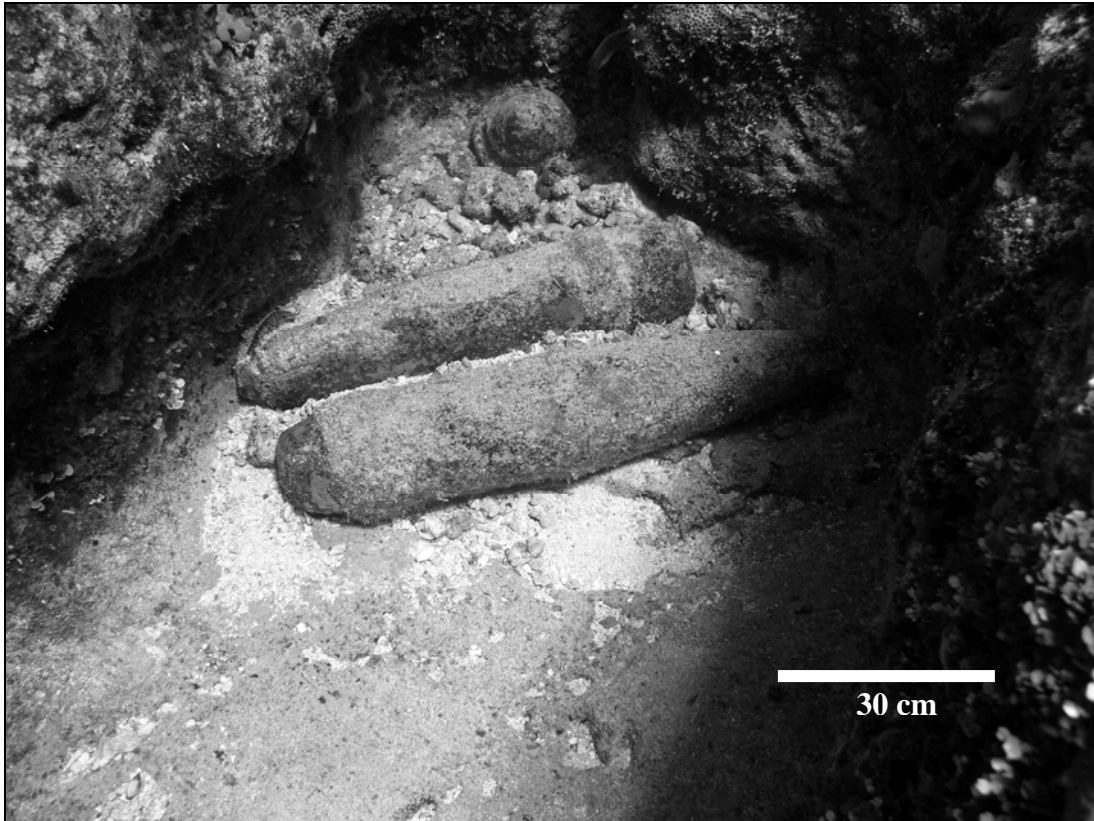
Photo 31. A pair of ordnance in a crevice at site UXO 38.

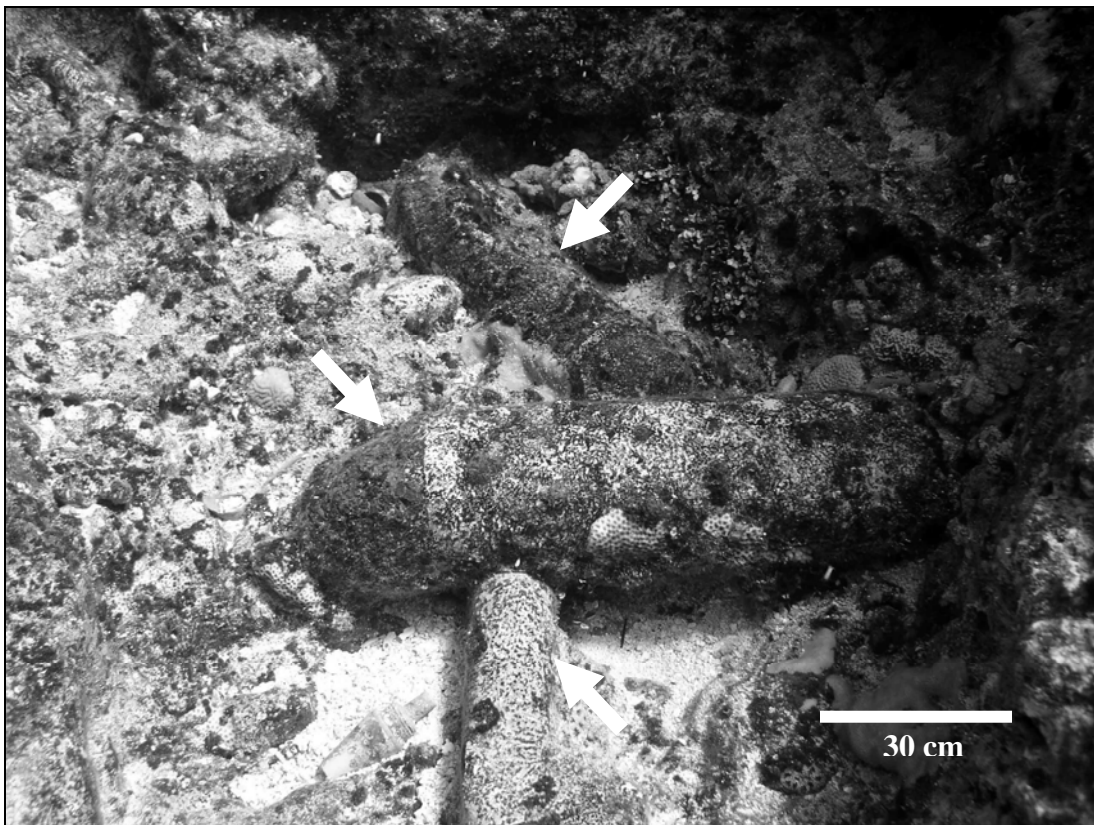
Photo 32. Ordnance in a crevice at site UXO 39.

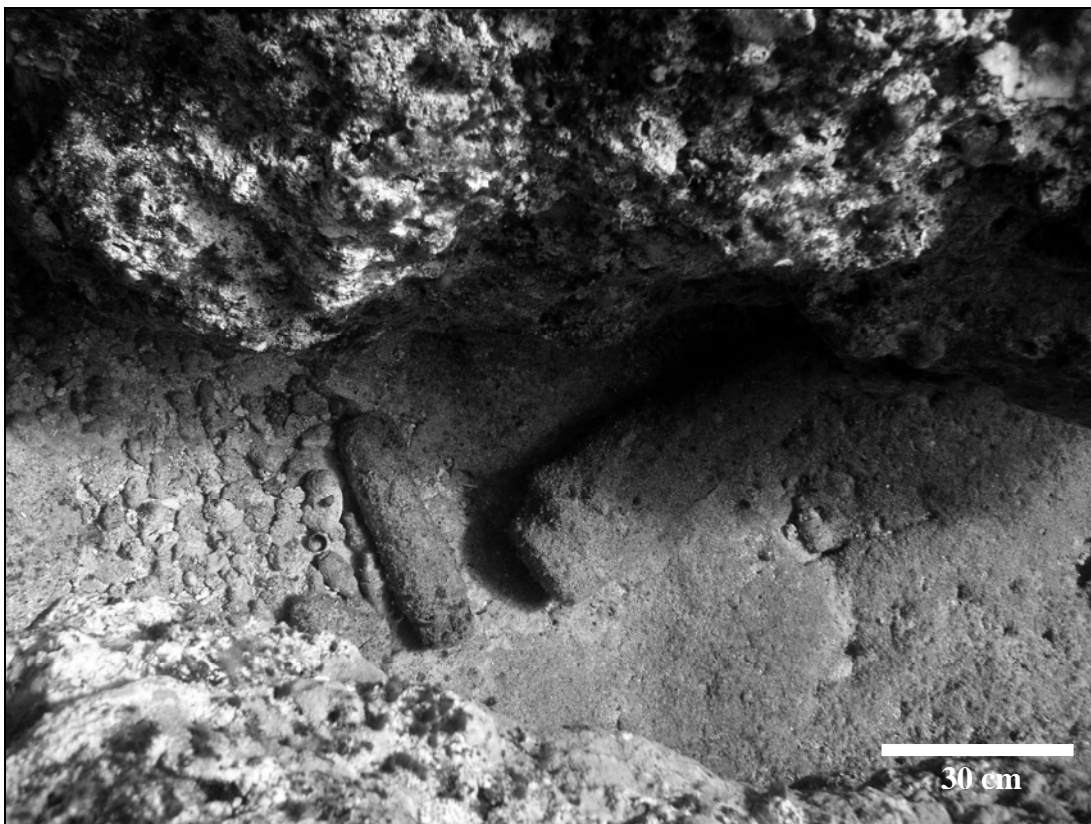
Photo 33. A pair of ordnance in a crevice at site UXO 40.

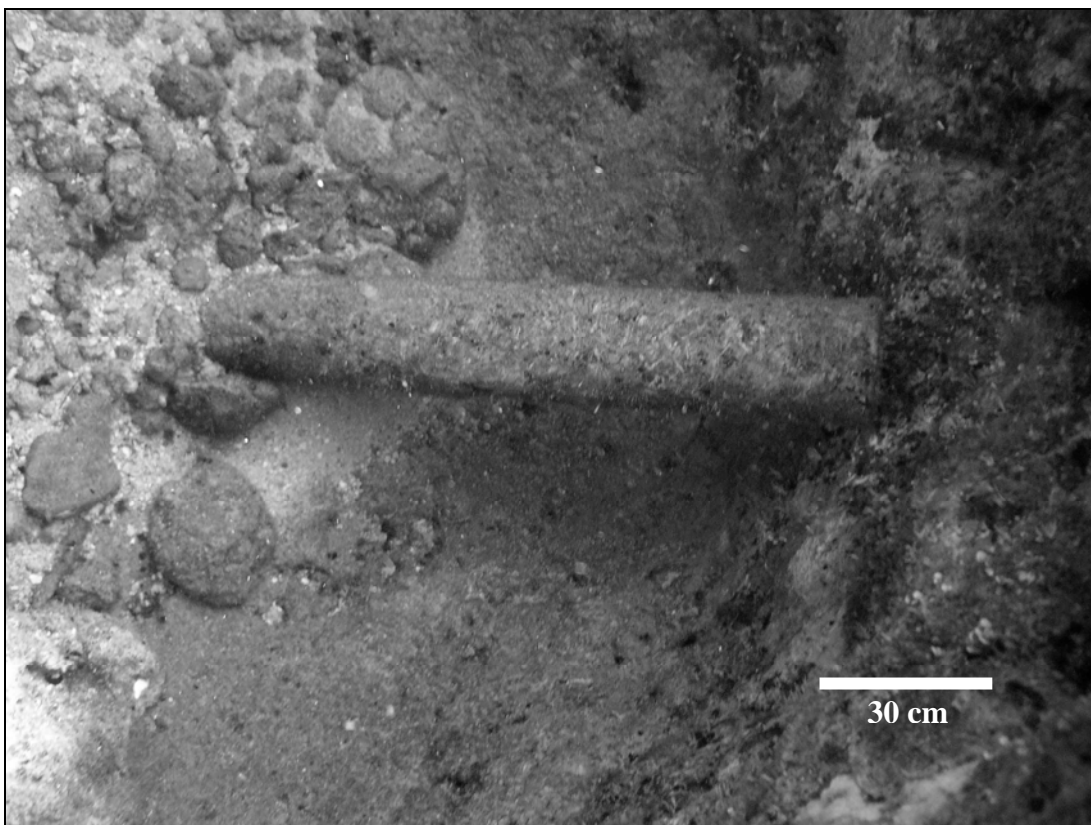
Photo 34. An ordnance rolls around in a crevice at site UXO 40.

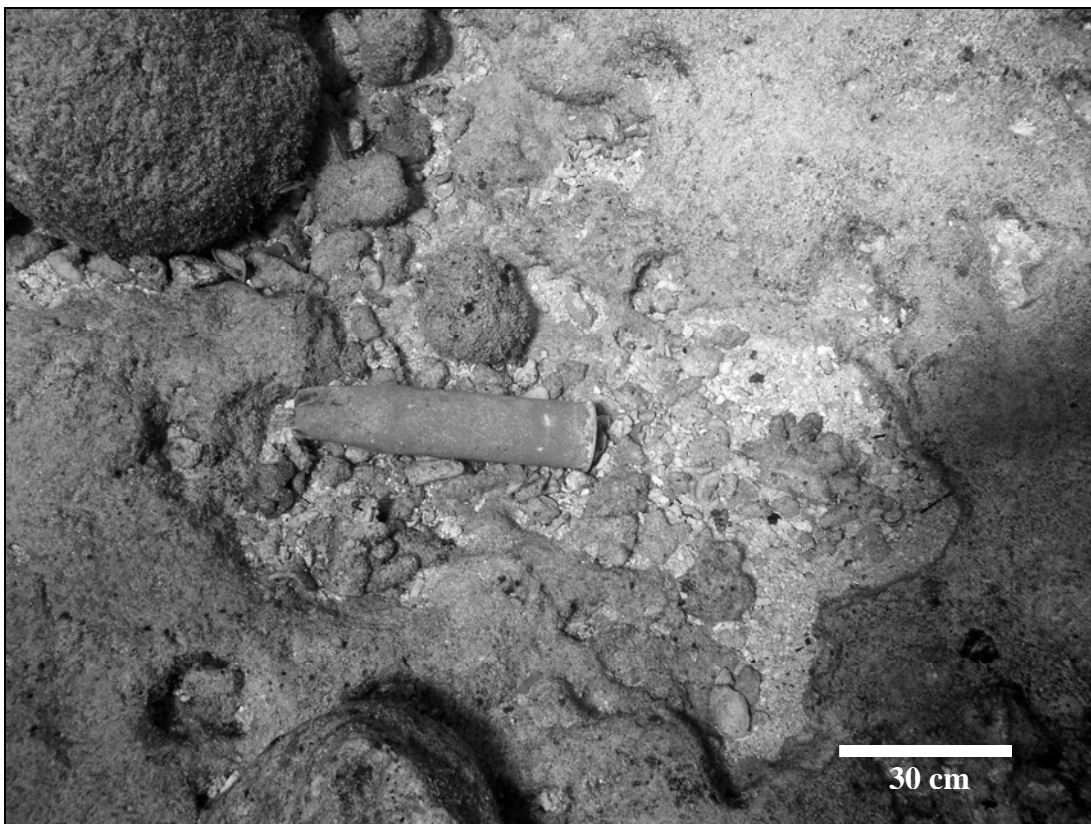
Photo 35. A damaged shell in a crevice at site UXO 41.

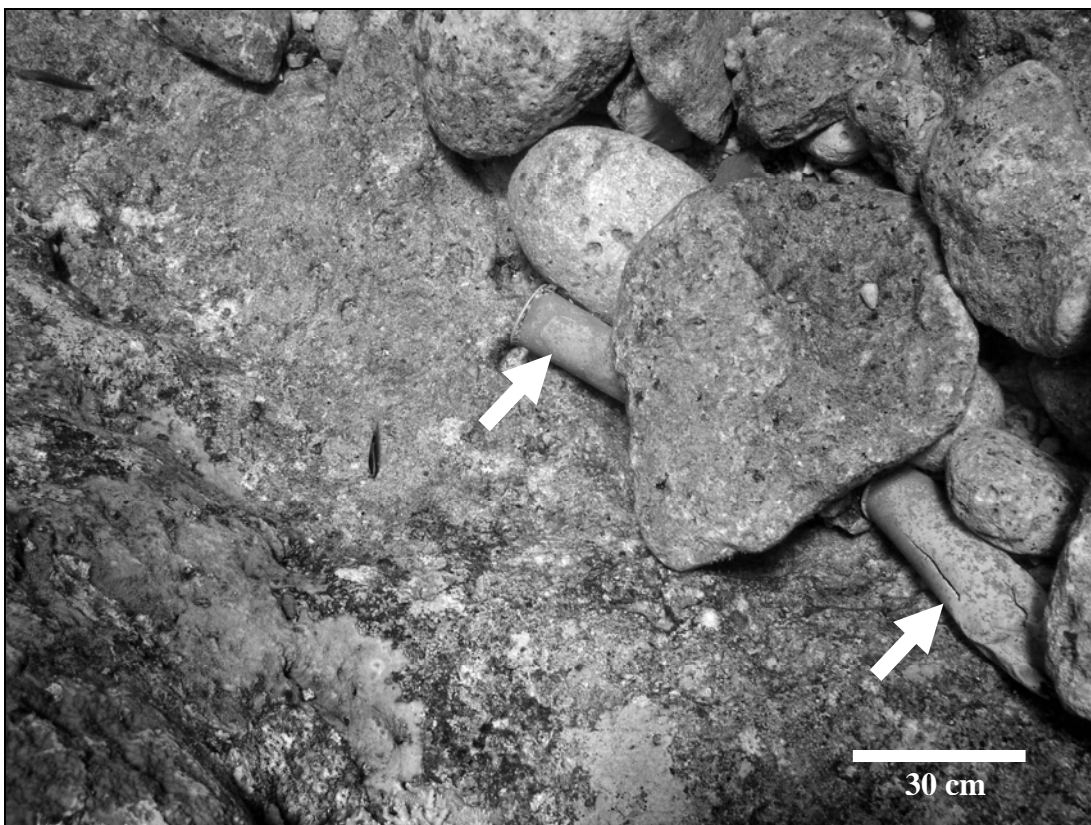
Photo 36. Two shells mixed with coral rubble in a crevice at site UXO 42.

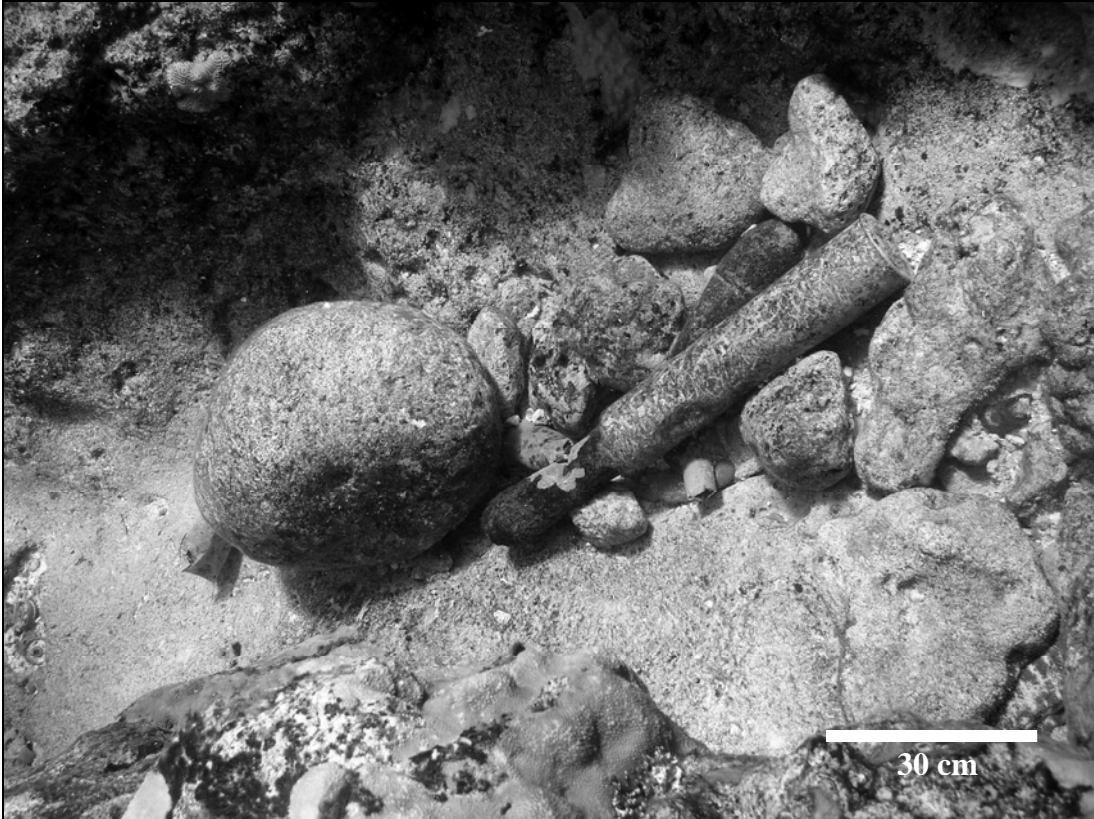
Photo 37. Coral rubble and ordnance in a crevice at site UXO 43.

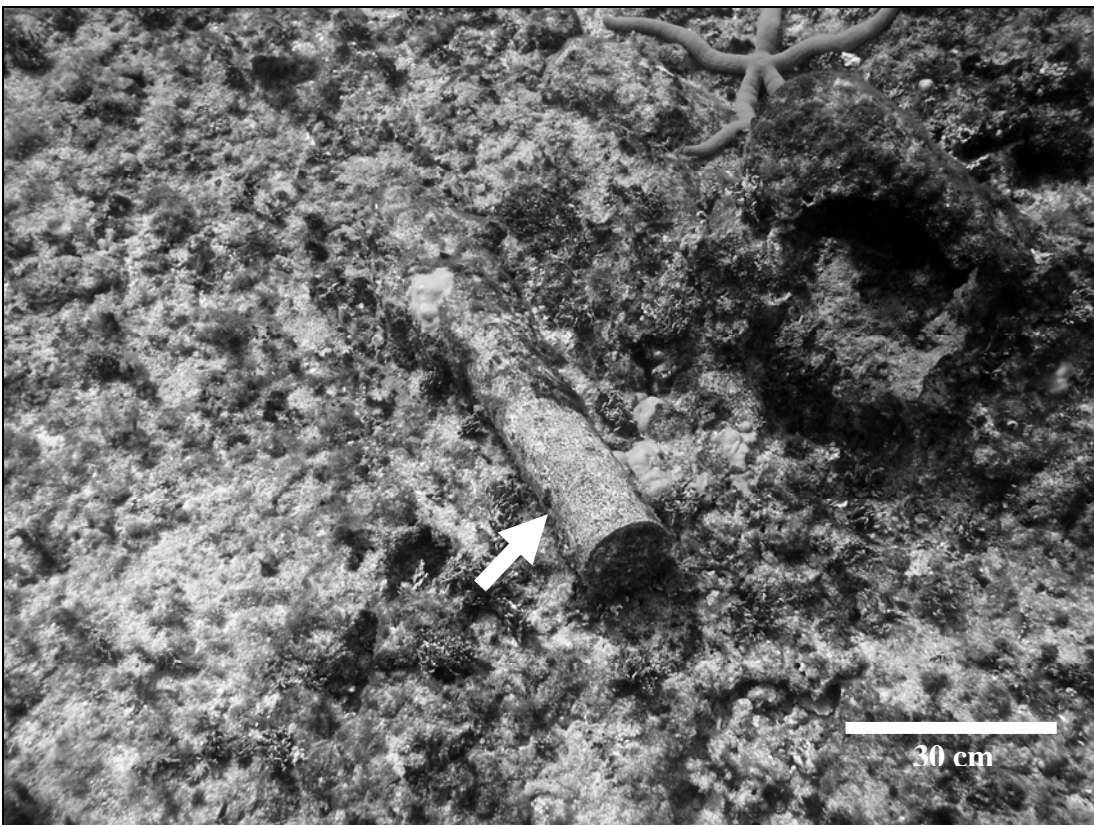
Photo 38. Ordnance at site UXO 46.

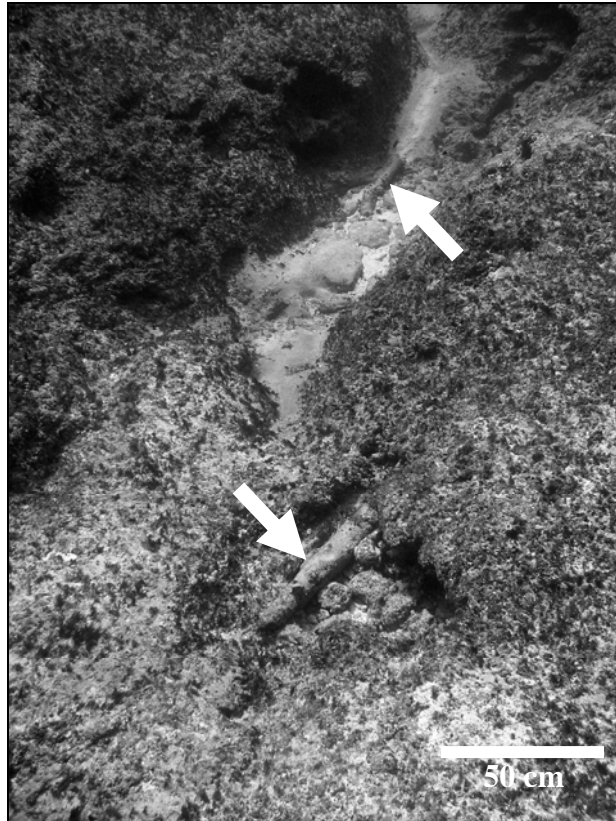
Photo 39. Ordnance in a crevice at site UXO 47.

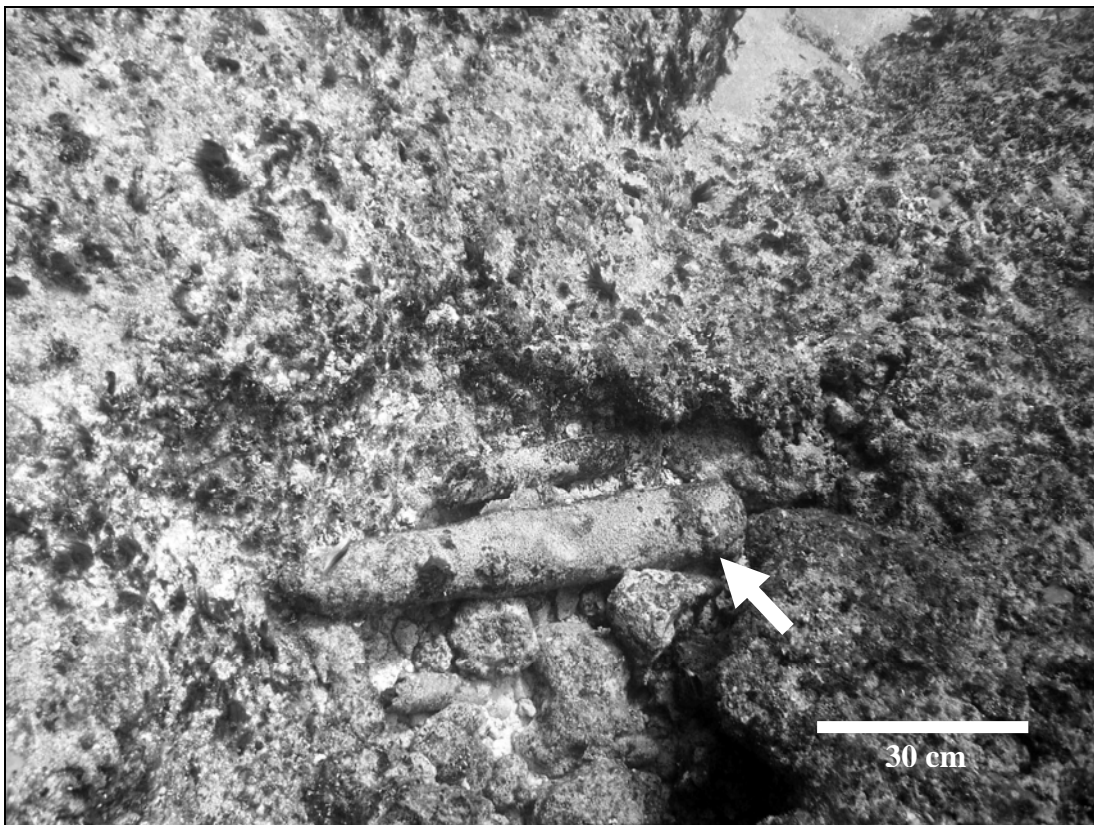
Photo 40. Ordnance at site UXO 47.

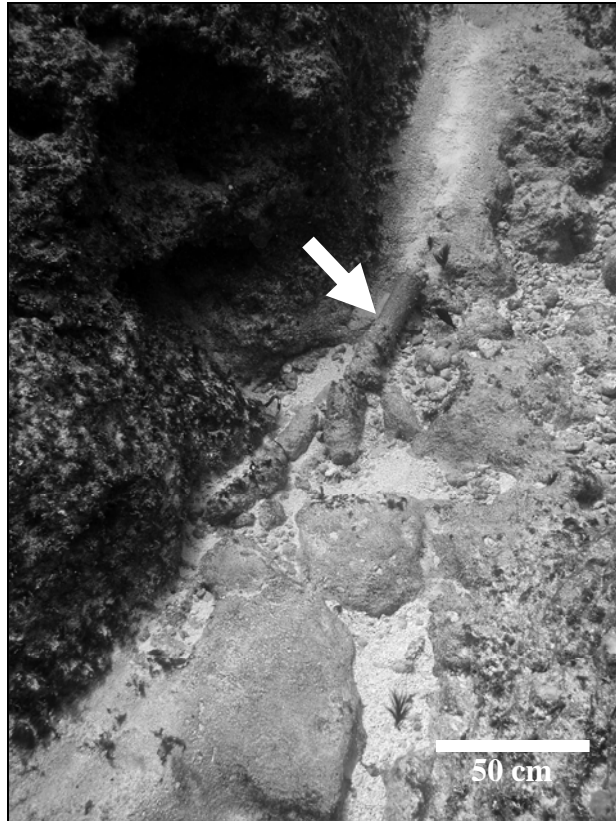
Photo 41. Ordnance at site UXO 47.

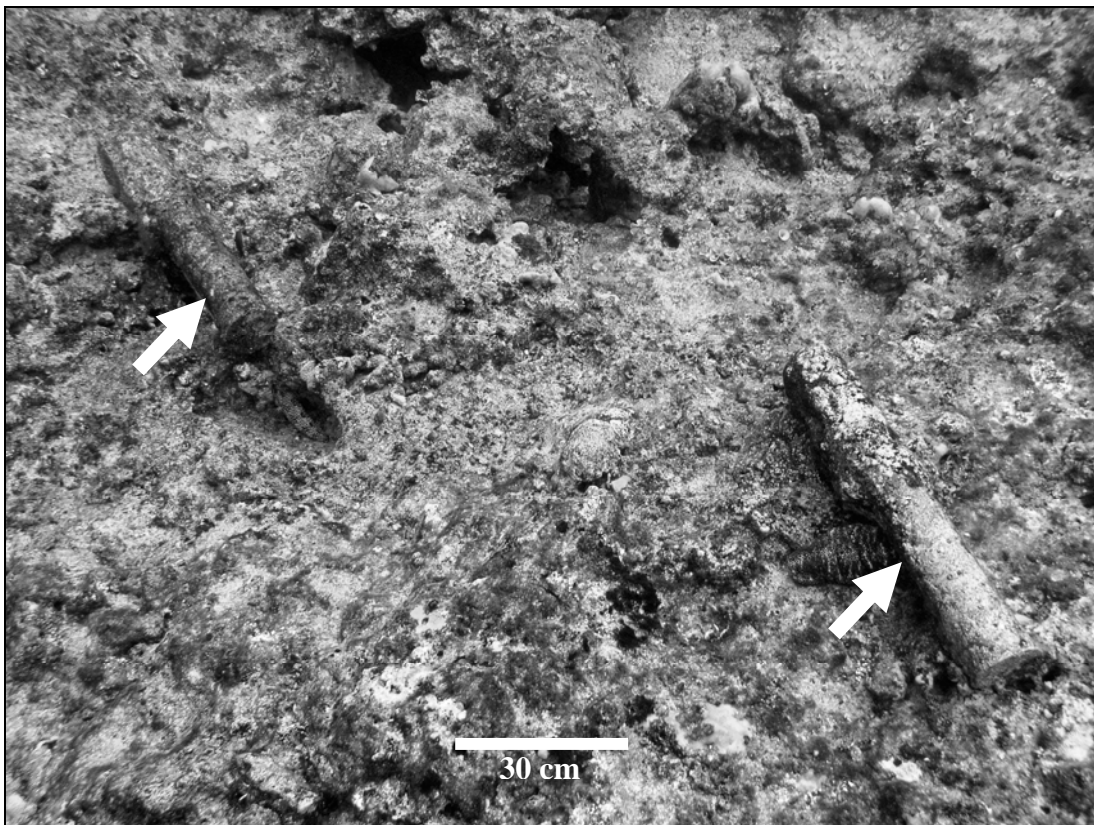
Photo 42. A pair of ordnance at site UXO 48.
